Manhole Inspection Summary

Manhole # S39E__025MH

Insp Date: **8/20/08 1:46 PM**

Location Address: **901 e fayette st**

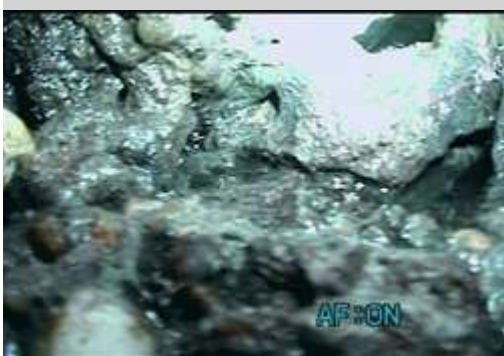
Defect 5

Condition: ☐ Sound ☐ Cracked ☐ Root Intrusion ☐ Deteriorated ☐ Leaks ☒ **Debris**

channel debris

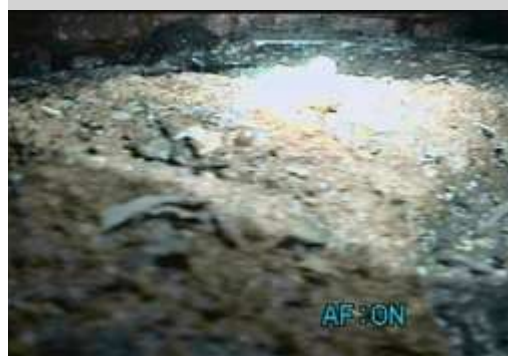
Defect 4

Condition: ☐ Sound ☐ Cracked ☐ Root Intrusion ☒ **Deteriorated** ☐ Leaks ☒ **Debris**

bench debris

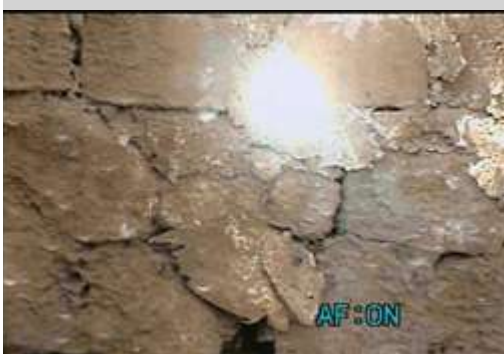
Defect 3

Condition: ☐ Sound ☒ **Cracked** ☐ Root Intrusion ☒ **Loose Brick** ☒ **Deteriorated**

Infiltration: ☐ None ☐ Joint ☒ **Cracks** ☐ Mortar ☐ Roots ☐ Wall

chimney cracked, loose bricks,
deteriorating, frame adj, infiltration

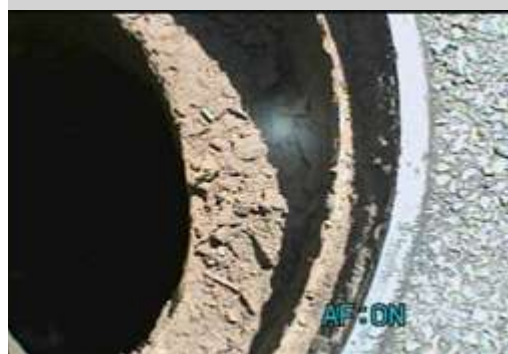
Defect 2

Offset: **2.5** (in.)

offset

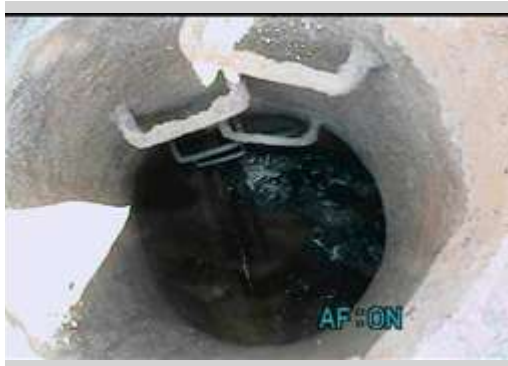
Defect 1

Count: **6** Missing: **0** ☒ **Corroded**

steps

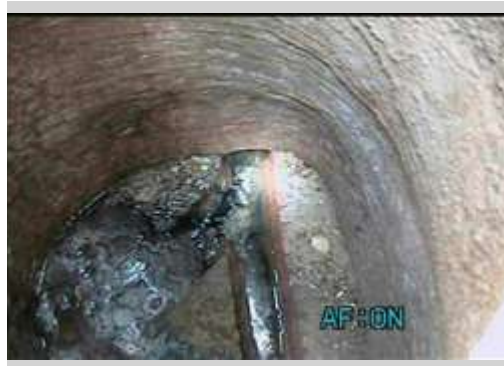
Defect 6

Deteriorated bench

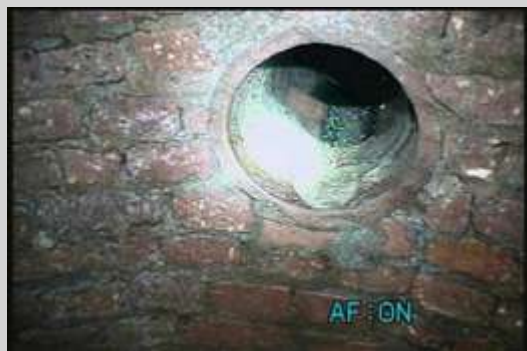
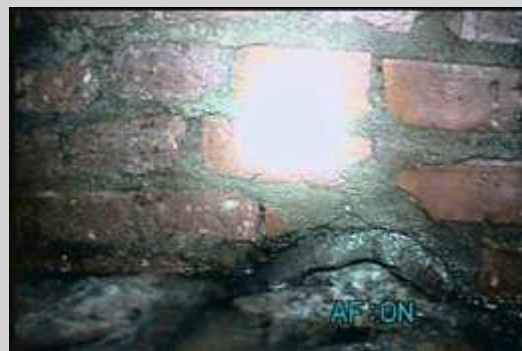
9 O'Clock Inflow

Drop Condition: **Partly Clogged**
